*Septic reports on 495 Quinary Estate
Re: Wendy Green*

Septic System Inspection Report

Property Address 495 Country Estate Terrace, Bonny Doon, California

SEPTIC TANK PUMPING AND INSPECTION REPORT

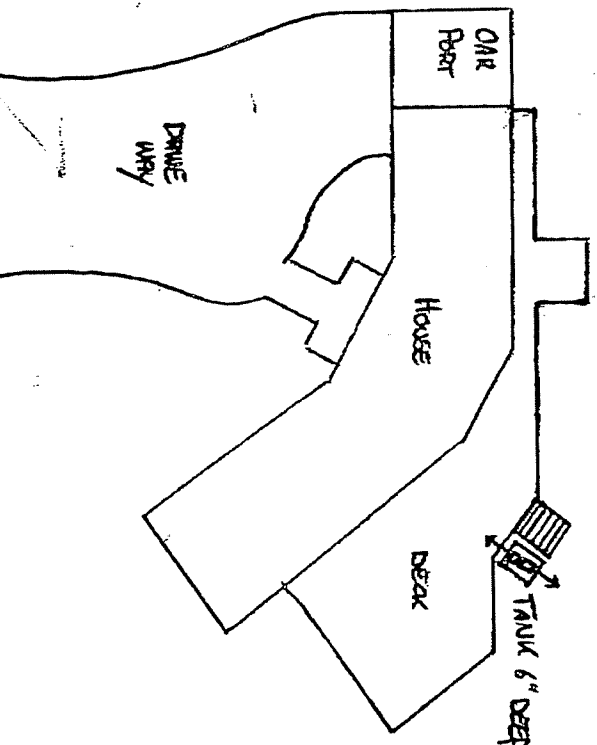
SYSTEM LOCATION (SKETCH OR DESCRIBE, WITH MEASURED DIMENSIONS AND DIRECTION OF NORTH; INCLUDE ANY PERTINENT FEATURES SUCH AS PAVED AREAS, SURFACING EFFLUENT, CREEKS, LARGE TREES, ETC.)

Condition of tank and baffles Good condltion

Type and condition of lid Concrete lids, good condltion

Does level of tank indicate drainfield failure No

Are there wetspots, or any other indication of drainfield failure No

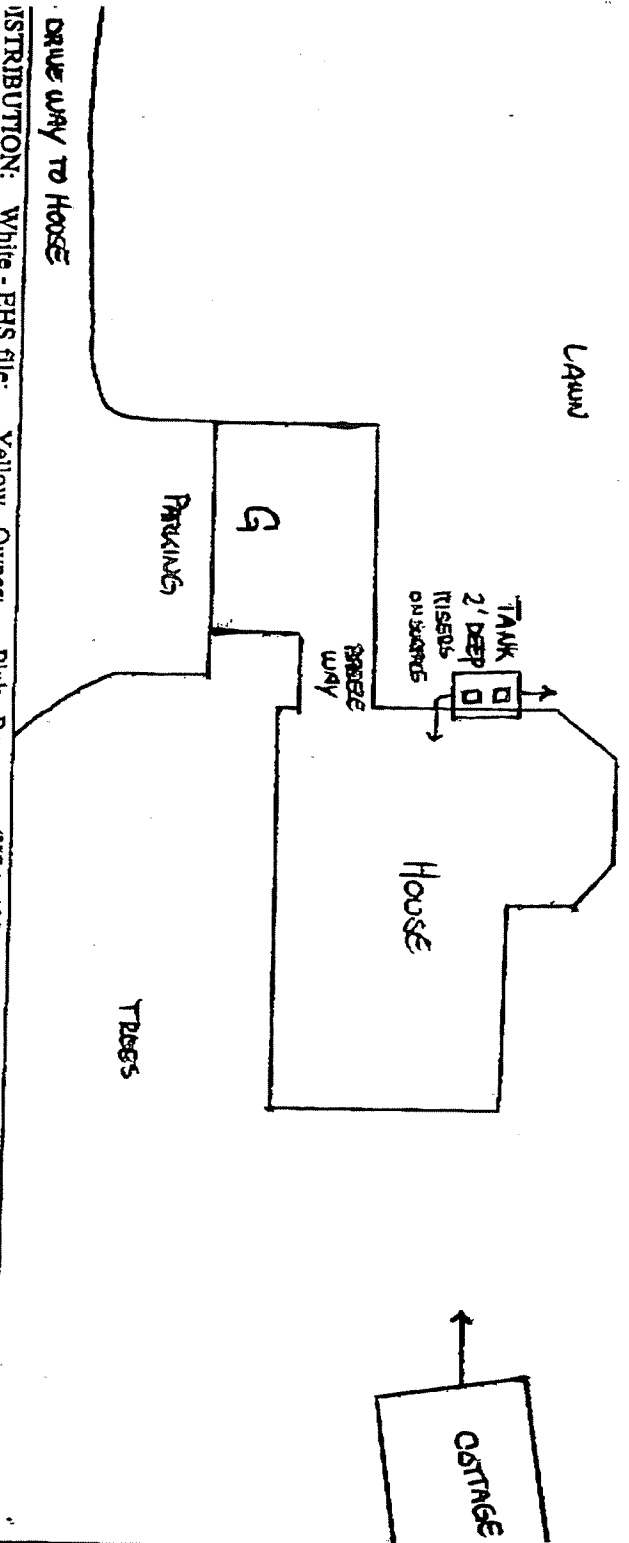
SYSTEM LOCATION (SKETCH OR DESCRIBE, WITH MEASURED DIMENSIONS AND DIRECTION OF NORTH; INCLUDE ANY PERTINENT FEATURES SUCH AS PAVED AREAS, SURFACING EFFLUENT, CREEKS, LARGE TREES, ETC.)

Condition of tank and baffles Tank, baffle good. Back elbow good
front elbow poor

Type and condition of lid Concrete lids, good condition

Does level of tank indicate drainfield failure No

Are there wetspots, or any other indication of drainfield failure No

Required repairs and comments Recommend repair front elbow
